TECHNICAL REPORT ARCCB-TR-98014

**FAILURE ANALYSIS OF AN 84-MM, M3,  
CARL GUSTAF, RECOILLESS RIFLE**

**US ARMY ARMAMENT RESEARCH,  
DEVELOPMENT AND ENGINEERING CENTER  
CLOSE COMBAT ARMAMENTS CENTER  
BENÉT LABORATORIES  
WATERVLIET, N.Y. 12189-4050**

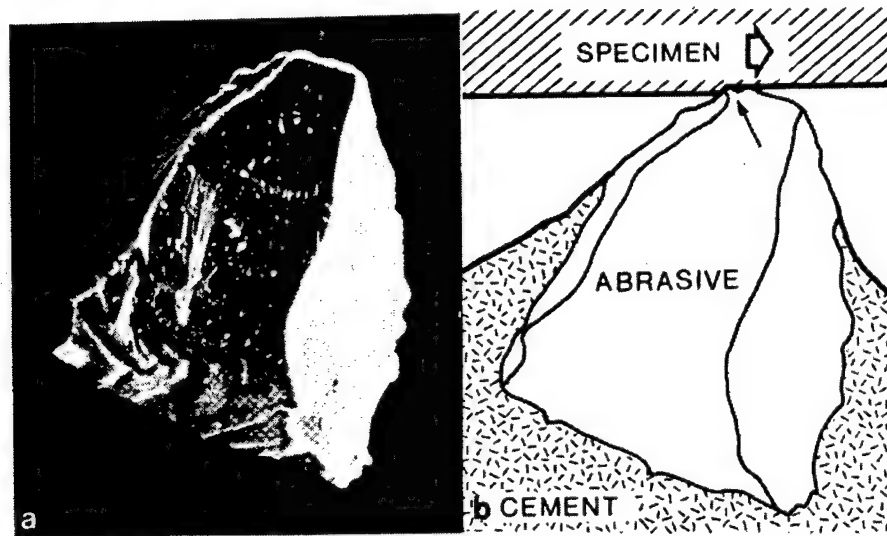
Figure 7. Photograph and action of an abrasive particle on a surface (ref 1)

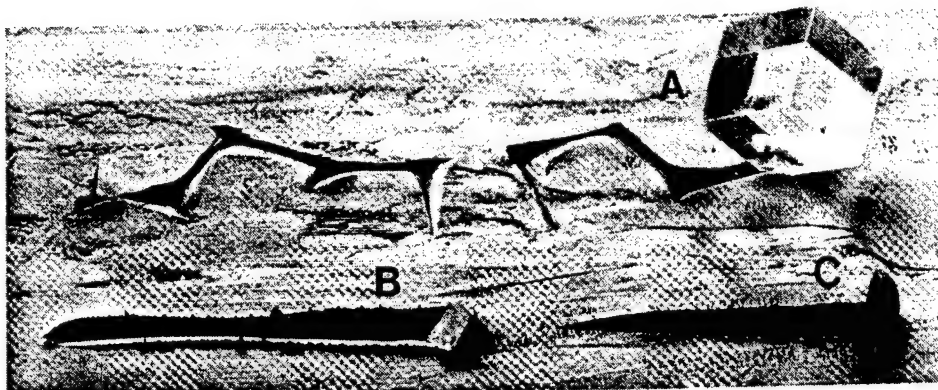
Figure 8. Surface marks caused by the action of an abrasive particle (ref 1)

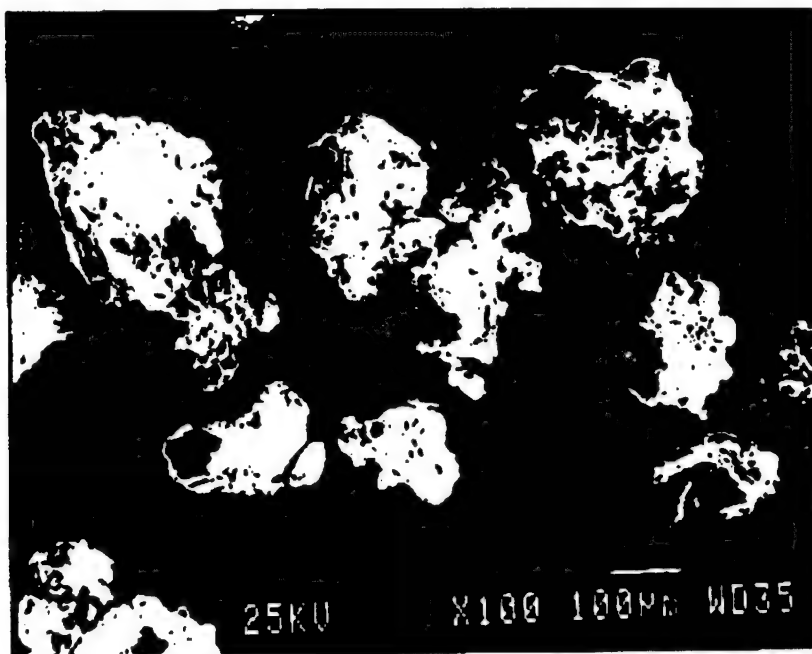
**FIG.#1**

Particles were also extracted from the venturi. Figure 1 shows these venturi particles to be equiaxed (as opposed to film-like), while EDX Figures 1A and 1B show them to be rich in Si. Figure 1A is consistent with silica, and Figure 1B is consistent with silicate. Silica ( $\text{SiO}_2$ ) occurs widely in nature as sand, diatomite, quartz, flint, etc. Silicates are any of the widely occurring compounds of Si, O, and one or more metals, with or without hydrogen. Typical natural silicates are gem stones (except diamond), beryl, asbestos, clay, talc, feldspar, etc. There are also several types of clays (e.g., hydrated aluminum silicate) that are found in soils in varying percentages. Figure 1B is qualitatively consistent with feldspar (a potassium aluminosilicate). The hardnesses of silica (quartz) and feldspar are 820 and 560 Knoop (100 g load), respectively (ref A-1). If the conversions are correct at this low load, this is approximately 59 and 47  $R_c$ , respectively. Both of these are harder than the metal rifle liner, which is approximately 28 to 32  $R_c$ . The hardness of all types of clay could not be ascertained, but those that were found are softer than silica and/or feldspar. Silica melts at 1986 K—approximately 1000 lower than the reported gas temperatures in the rifle bore. Because they are softer, the melting point of feldspar and clay is probably lower than silica. The melting point of the debris may be important because much of the material found in the bore resembles a smeared film (as opposed to equiaxed particles).
